Preservation Master Plan

Virginia Military Institute

FINAL REPORT – JANUARY 2007

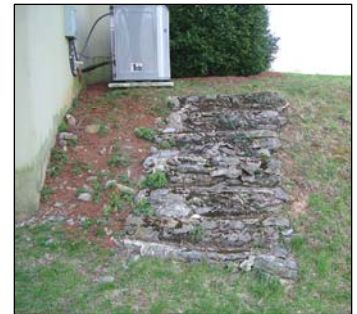
Stacked and mortared stone at 410 VMI Parade is in poor condition.

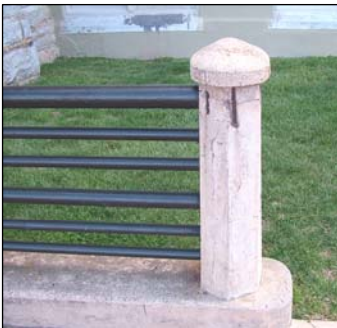
Existing concrete bollards are generally in poor condition.

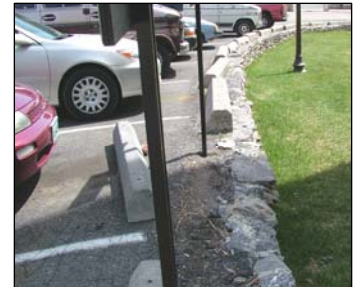
Asphalt parking in front of Scott Shipp Hall has concrete wheel stops atop a deteriorating stone retaining wall.

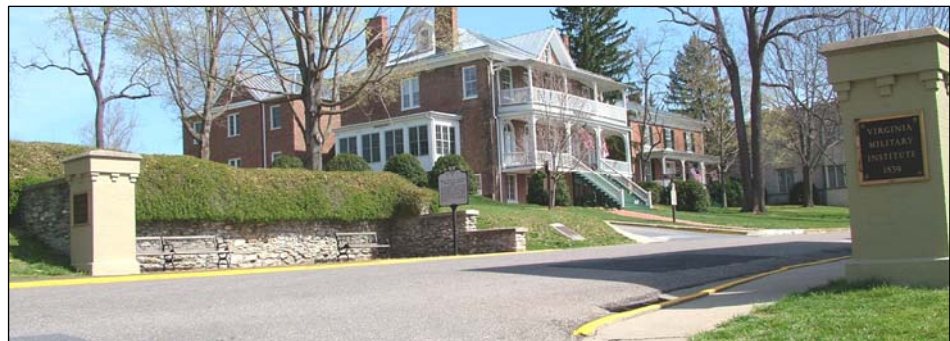
View of South Institute Hill shows landscape structures in good condition, including the historic Limit Posts.

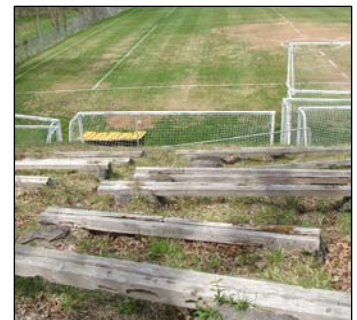
Wooden bleachers overlooking the lacrosse field are in poor condition due to settlement and decay.
