Preservation Master Plan

Virginia Military Institute

FINAL REPORT – JANUARY 2007

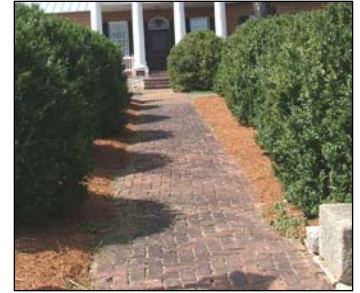
size, style, and condition to the Stono brick walk. Both of these sidewalks exhibit uneven surfaces from settlement of the sub-grade.

The pedestrian walk leading to Stono is constructed of dry-laid brick in a herringbone pattern.

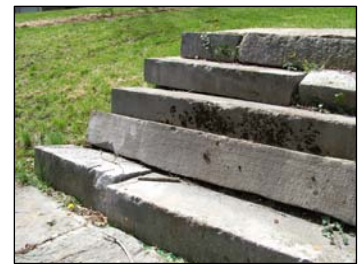
To the north of Stono, a series of cut limestone block steps provide a formal entry to the terraces. These steps are in poor condition and exhibit cracks and irregular settlement angles. A concrete sidewalk parallels Stono Lane on its north side. Each of the three primary buildings has a front walk that links to this sidewalk. Photos indicate that this sidewalk was in place as early as 1920, although it was historically paved in brick.

Cut limestone steps provide access to the terraces at Stono but are in poor condition.

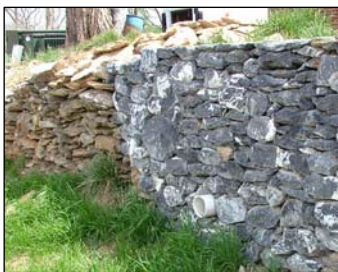
Replacement walls are not consistent with historic walls in color and materials.

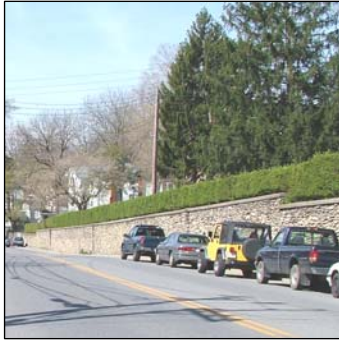
Stone walls along Main Street range from eight- to fifteen-feet in height.

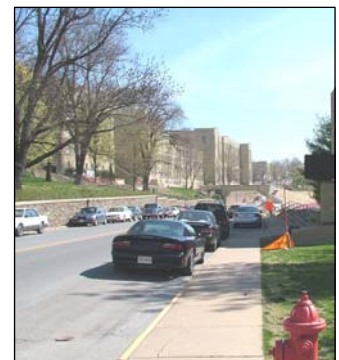
Concrete sidewalks comprise the limited pedestrian circulation system on South Post.

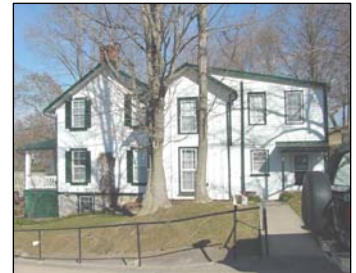
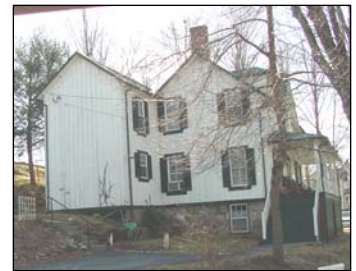
The residences at 501 Brooke Lane, above, and 503 Brooke Lane, below, have poor historic landscape integrity.

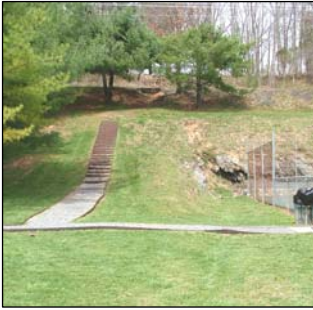
Chessie Nature Trail is accessed on North Post by way of steps located near the tennis courts.

North Post contains two walking trails. The Chessie Nature Trail is a rails-to-trails project along the bed of the former Chesapeake & Ohio Railroad right-of-way between Lexington and Buena Vista. The portion on VMI property is seven miles long and runs along the north ridge. It can be accessed via steps near the tennis courts. These steps are framed by metal edging filled-in with crushed gravel. Another series of steps and pathways provide access from the tennis courts parking lot. All steps are in poor condition and constitute a safety hazard due to their uneven nature and settlement.

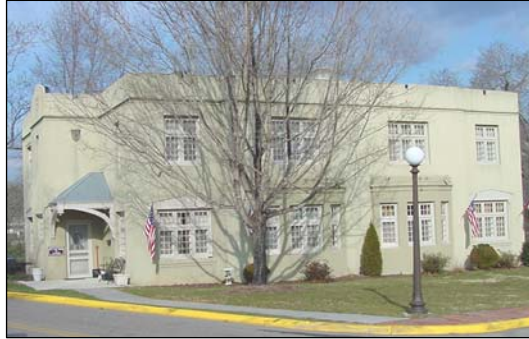
402-404 VMI PARADE

Typical conditions at 402-404 VMI Parade include minor damage to exterior and interior finishes. Hairline cracks run through the exterior stucco, highlighted by dark patches where water is absorbed into the crack. These hairline cracks will eventually cause the stucco to fail. There is also minor paint failure at wood windows and other exterior wood trim. On the interior, the building is in good condition. However, the plaster on lath has cracked at the ceilings and walls, probably from a combination of water damage, settlement, and installation problems.

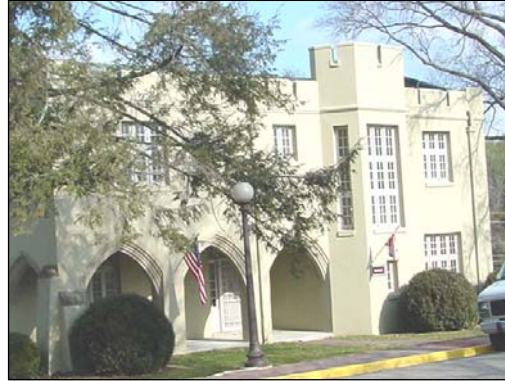
406 VMI PARADE

The rear chimney at the projecting ell is beginning to twist under the forces of thermal expansion. This chimney should be monitored annually. It will need to be rebuilt in order to stabilize the upper portion. Maintenance level work is required at the wood windows, where the paint is beginning to deteriorate.

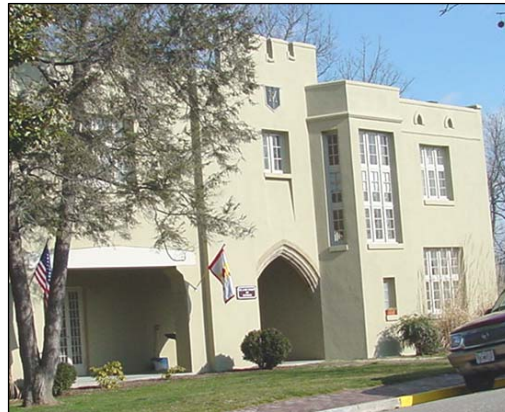
408 VMI PARADE

Overall, 408 VMI Parade is in good condition. There is evidence of overflowing downspouts on the north façade, stucco failure, and deterioration of concrete paving. Downspouts, particularly at the northeast corner of the projecting ell, show evidence of chronic overflow, causing erosion of the adjacent soil. The beginning of stucco failure has begun with evidence of hairline cracking. Stucco at the east chimney shows advanced signs of failure as the underlying metal lath has corroded and caused staining on the exterior. The concrete pad at the north, brick-paved patio exhibits signs of reinforcing bar corrosion and efflorescence. Water is moving through the concrete pad, accelerating corrosion, and depositing salts on the exterior surfaces. Both the stucco and the concrete pad will have to be replaced.

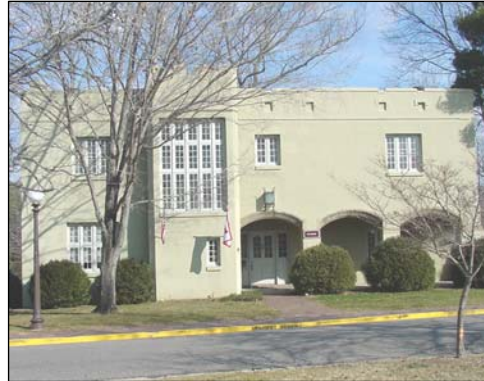
410 VMI PARADE

On the interior, cable has been installed in an inappropriate manner. The cable has been run up the exterior and cut in through the wood window sill. Future work of this type should be coordinated with maintenance and preservation staff to ensure that it is done without damaging historic fabric.

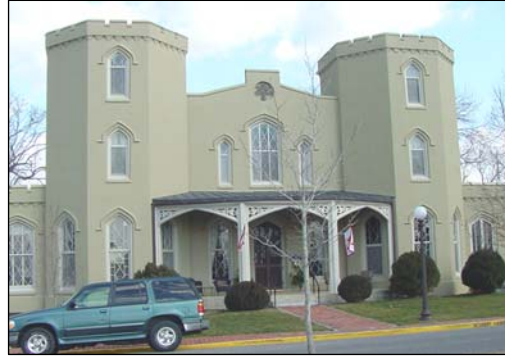
412 VMI PARADE (SUPERINTENDENT'S QUARTERS)

The exterior colors of 412 VMI Parade do not appear to be historically accurate. Window sash, muntins, and frames were painted a dark hue in historic photographs. Also, the stucco color appears to be greenish and should instead be a more natural stone color. Paint analysis at both stucco and wood trim elements would help identify appropriate period colors.

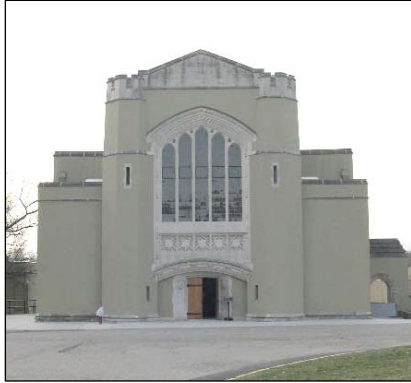
JACKSON MEMORIAL HALL

The exact location of roof drains at Jackson Memorial Hall is unknown. It appears that the main roof directs rainwater to the lower side aisle roofs, which have internal downspouts. These internal downspouts empty into external downspouts near the lower levels. It was noted that the external downspouts direct water in inappropriate places. For example, the downspout at the southeast corner drains directly onto a concrete ramp. There is no provision for proper drainage.

The stucco at Jackson Memorial Hall is in the early stages of failure. There is hairline cracking and efflorescence overall. The western stairs appear to have more advanced stages of stucco failure. It is probable that water is infiltrating through the upper surface of steps. The limestone trim requires cleaning with a biocide-containing cleaner to remove biological growth at wash surfaces. The limestone base course has extensive spalling and has been inappropriately patched. Loose patches should be removed and replaced with new cementitious patching or with limestone dutchmen.

Related retaining walls at entrances show signs of movement or settlement. At the southeast entrance, the cast stone coping units are loose. The cast stone units should be reset in a full bed of mortar and the wash surface joints should be sealed.

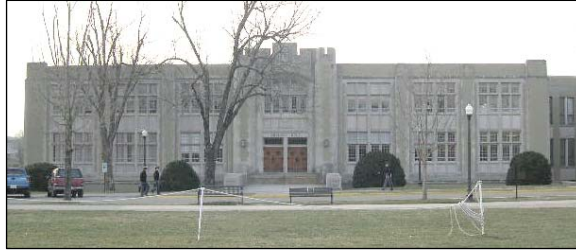
MALLORY HALL

The main preservation concern at Mallory Hall is the condition of the limestone trim, especially over the main entrance. The limestone exhibits both spalling and delamination, potentially caused by corroding anchors. The cause of limestone deterioration should be investigated. Corroding anchors could potentially damage the carved limestone detailing.

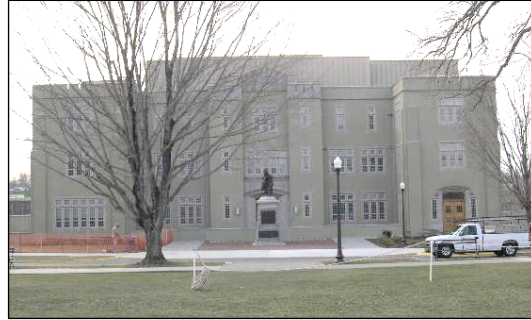
NICHOLS ENGINEERING

Nichols Engineering has been recently renovated and is in good condition. The joints at the cast stone trim have been inappropriately pointed with sealant. The sealant will trap water within the masonry walls, forcing water to escape through the masonry or stucco coating. Sealant is only appropriate for joints located at wash surfaces. All other joints, including joints at the base of capstones, should be pointed with a cementitious mortar that is less dense than the masonry.

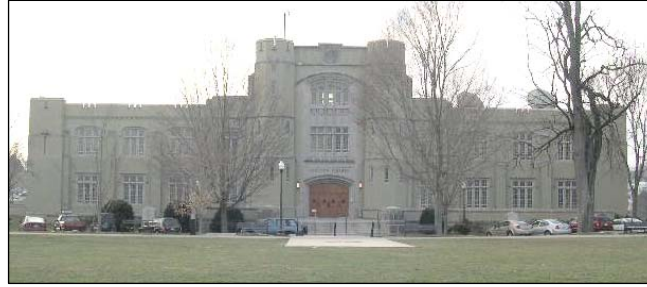
PRESTON LIBRARY

The Preston Library is in good condition overall. The concrete foundation has map cracking and efflorescence, indicating water is moving through the foundation in these locations. Several features require maintenance level work. The metal sash windows are corroding, particularly in the location of hinges and moving hardware. At the main north entrance area, there is minor cracking at the cast stone capstones. Sealant joints have failed and water is entering through these joints. There is also evidence of salt damage at the slate paving which has likely been caused by the use of deicing salts.

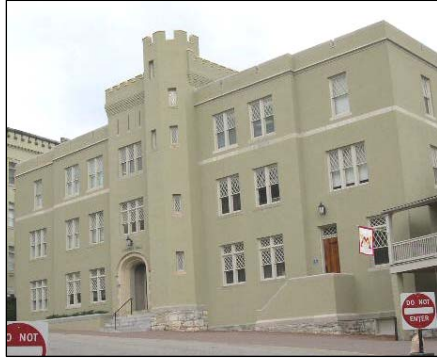
CARROLL HALL

The main south entrance at Carroll Hall shows deterioration from wear and weather. The limestone entrance steps have cracked and have been repaired with iron dowels. Both the dowels and the handrail posts are beginning to corrode. Ongoing corrosion of these embedded metal items will cause more disruption of the stone steps. The concrete threshold has exposed rebar reinforcement and delaminating concrete. The varnish on the main entrance doors has deteriorated and the wood is exposed and dry.

Overall, the paint has begun to deteriorate at the wood windows. The masonry at the foundation water table course is delaminating, probably from damage caused by deicing salts. Several prior patch repairs have failed. The limestone trim has been coated with an orange coating that has discolored the stone.

Sealant has been inappropriately applied as a raised ribbon joint. Sealant should be applied as a concave joint, supported by foam backer rod. Raised ribbon joints fail very quickly, allowing water to penetrate into the joint. The large raised joint gives a false sense that the joint is adequately sealed.

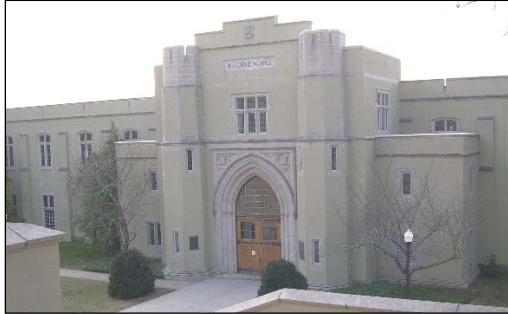
COCKE HALL

Cocke Hall is in good condition overall. Maintenance level work is required at exterior windows and doors. The metal casement sash and French doors show signs of early corrosion, particularly at hinge locations. The varnish on exterior wood doors is deteriorated, leaving the wood dry and exposed to the weather.

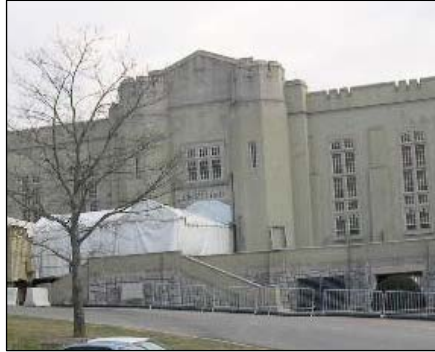
CROZET HALL

The primary preservation concern at Crozet Hall is the condition of the original metal windows. The original metal sash exhibit overall corrosion, especially where the glass panes have been removed. Ongoing corrosion has caused causing staining at the cast stone sills. The new design also offers potential locations for birds to nest.

Sealant has been used to point the cast stone trim. The sealant has been applied as a wide raised ribbon, which has failed. All non-wash surface joints should be pointed with a cementitious mortar. Sealant retains moisture in the wall and does not allow it to escape.

The stucco is showing signs of early failure. There is map cracking and efflorescence, particularly near the foundation. The main west façade also has areas of detached stucco. The varnish at the exterior entrance doors is beginning to fail. On the interior, the original ventilation skylights have been by-passed but leaks have not been corrected. This band-aid type work will lead to chronic leaks in the renovated facility.

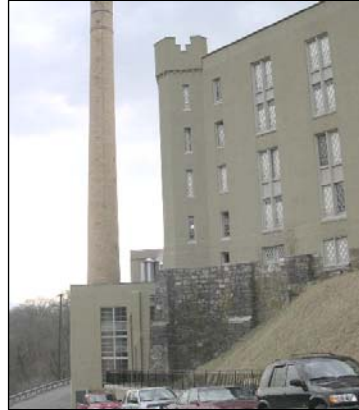
HEATING PLANT

The Heating Plant is generally in good condition. The steel windows show minor signs of corrosion.

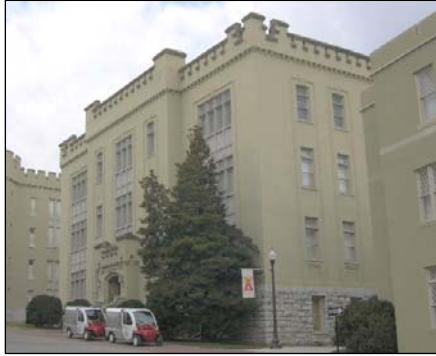
MAURY-BROOKE HALL

Maury-Brooke Hall is in good overall condition. However, several maintenance level repairs are required. The painted stucco coating is beginning to deteriorate, particularly at the parapet level. The paint is beginning to peel and fail at the wood windows. The limestone trim is blackened with biological growth, which should be removed with regular cleaning. The main south entrance cheek walls require overall repointing at both capstones and walls. The limestone foundation has been pointed with wide joints feathered over the edges of the worn stone. This type of pointing work is prone to early failure. Hairline cracks have formed at the feathered edges allowing water to infiltrate the masonry.

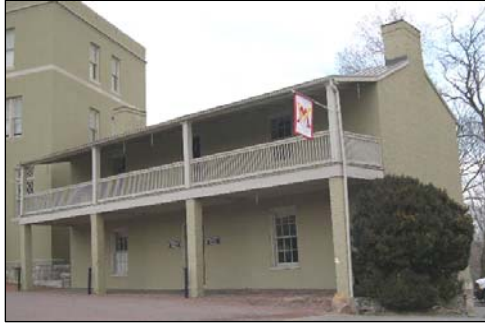
OLD HOSPITAL

The Old Hospital is in good condition overall. Minor deterioration was noted at the brick porch piers. The damage at the brick appears to be caused by rising damp and salt damage; it is not severe. In addition, the paint is beginning to deteriorate at the wood windows.

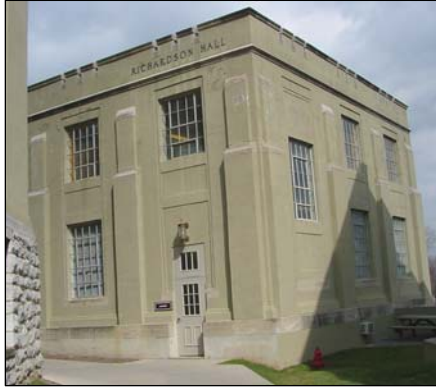
RICHARDSON HALL

Richardson Hall requires overall rehabilitation of exterior masonry, stucco, and metal windows. Both the stucco and cast stone exhibit hairline cracking. Efflorescence has formed around these cracks indicating that water is moving through the masonry. In some areas, the stucco and cast stone have begun to delaminate from chronic water infiltration. The foundation joints have been inappropriately sealed. Sealant was applied over old mortar, with no foam backer rod installed. The sealant joints have prematurely failed and are allowing water into the cast stone masonry. The metal windows require painting to protect the sash from corrosion.

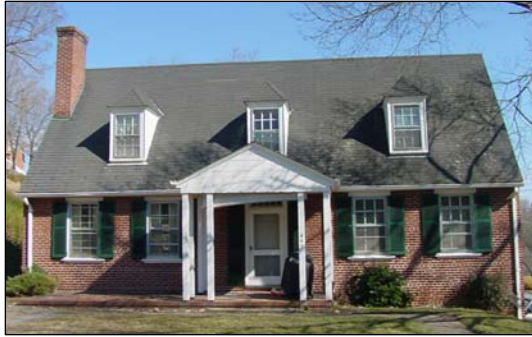
443, 445, 447, 449, 451 INSTITUTE HILL

All five bungalows are in good condition. There is some evidence that gutters are chronically clogged and overflow.

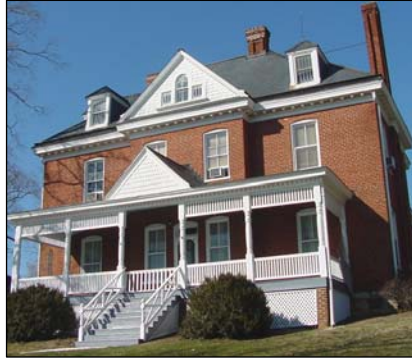
450 INSTITUTE HILL

There is also evidence of drainage issues. At the rear ell, the west box gutter shows signs of chronic overflow. Biological growth is heavy on the outer face. At the west façade, the downspouts direct water runoff directly against the building foundation. Extenders have been installed at the northwest corner, but some are disconnected.

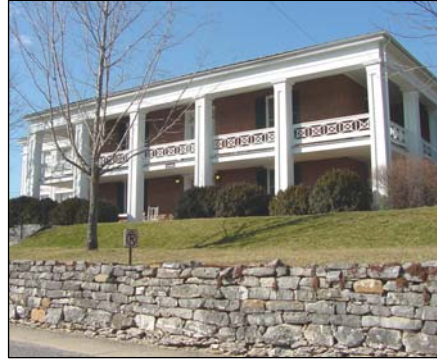
POST HOSPITAL

The Hospital is currently in good condition. Minor corrosion was noted at the east wing steel casement windows, particularly at hinge locations.

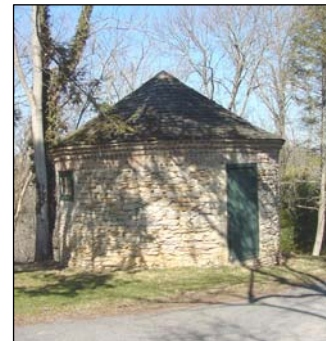
ICE HOUSE

The exterior of the Ice House was originally covered with stucco, as shown by the use of brick and stone masonry as well as by the remnants of stucco material. It is not known whether the windows, door, and roof are original or replacements in kind. More research is required to investigate these features.

The Ice House is in poor condition. The wood shake roof is failing and must be replaced. From its current appearance, the structural framing may also need to be replaced. Ivy is growing on the Ice House masonry. The masonry was originally stuccoed, which would have provided a very different appearance than exposed masonry.

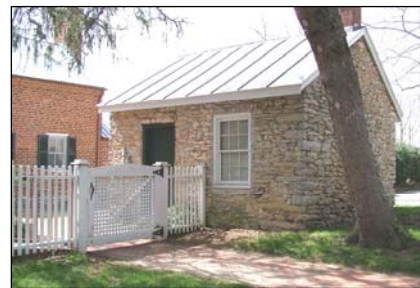
SUMMER KITCHEN

The Summer Kitchen is in overall good condition. The Summer Kitchen metal roof is beginning to corrode. The exterior once had a coating of stucco, which would have protected the soft masonry joints. On the interior, the plaster has cracked in several places. The fireplace surround has large cracks from thermal fluctuations in this unconditioned space.

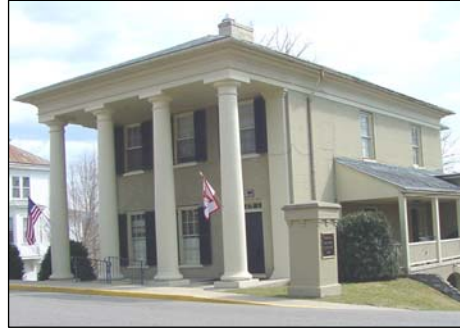
301 LETCHER AVENUE (BACHELOR OFFICERS' QUARTERS)

The most significant preservation concern at 301 Letcher Avenue is the cracking and building settlement occurring at the northeast corner. A downspout drains the northeast corner of the roof and directs water to a depression adjacent to the foundation. There is nowhere for the water to go except against the foundation or into the ground. The constant flow of water has undermined the foundation, causing cracks that run through the entire foundation wall. At the same location on the interior, there are chronic mold and water problems in the basement.

The situation is exacerbated by open joints at the building foundation and faulty gutters. The current gutters are corroding and bent. They do not have the correct slope to drain to the downspouts and are not angled correctly away from the building. Water drainage is a problem around the entire building. Paint is beginning to deteriorate at the wood trim, particularly the window sash. Window sills should be checked for rot given the poor gutter situation.

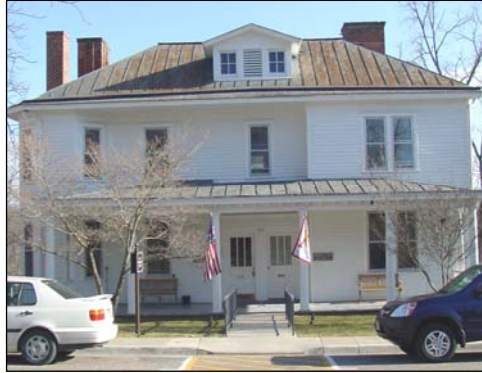
303 LETCHER AVENUE (VMI PROTOCOL)

The major preservation concern at 303 Letcher Avenue is roof drainage. The downspouts direct water to a concrete gutter at grade, which leads water towards the south. However, this concrete gutter is cracked and discontinuous. Extenders have been installed to direct water away from this gutter. There is also evidence of water pooling against the foundation. Furthermore, some downspouts are disconnected and drain water directly against the building. Chronic water infiltration in a wood frame building often leads to termite damage, especially in warm climates such as Virginia. The building should be regularly monitored for termites in order to prevent more extensive damage. In addition, the standing seam metal roof is corroding and must be refinished. Paint is beginning to fail at the wood siding. This is particularly evident in areas where water flows against the walls, such as near exterior wood stairs.

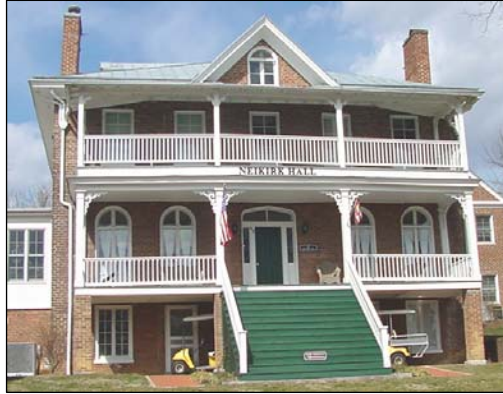
304 LETCHER AVENUE (BLAIR or NEIKIRK HOUSE)

Overall, 304 Letcher Avenue is in good condition on both the interior and exterior. The standing seam metal roof requires maintenance level painting. Portions of the roof have advanced areas of corrosion. Single downspouts at building corners drain multiple areas and may be overburdened. A water drainage capacity study is required to determine whether these downspouts are adequate.

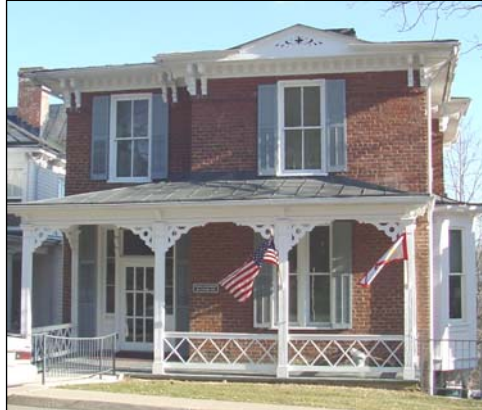
305 LETCHER AVENUE (LETCHEr HOUSE. HUMAN RESOURCES)

Drainage is the main preservation concern at 305 Letcher Avenue. On the west, the gutters appear to be overflowing. There is evidence of water splashing directly to the ground and spattering the foundation with dirt. Downspouts drain directly against the foundation with no provision for moving the water away from the foundation.

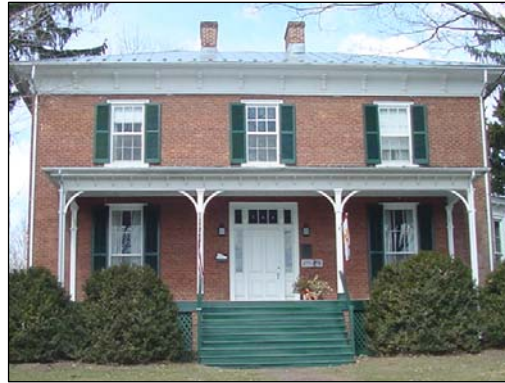
306 LETCHER AVENUE (CABELL OR ARCHER HOUSE)

Water drainage at the foundation of 306 Letcher Avenue has been an ongoing problem. The standing seam metal roof and hanging gutters appear to be new. However, masonry disruption, erosion, and rising damp are occurring where the downspouts drain to the ground. The brick masonry at the east foundation is disrupted by chronic water infiltration and mortar loss. At other locations, water is directed away from the foundation with splash blocks, but the ground has eroded and water now sits in swales close to the foundation. Biological growth at the foundation masonry indicates that it is chronically damp. Overall, water splashes from the gutters directly to the ground, washing dirt onto the foundation. These problems continue despite the new roof work.

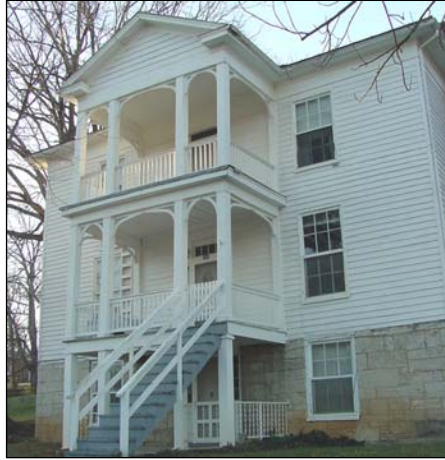
306 MAIN STREET

The primary preservation concern at 306 Main Street is site drainage. The roof drains to downspouts on the east and west facades. The downspouts in turn drain water into depressed areas adjacent to the foundation that are cut out of the slope. The water must flow south out of these depressions. Without the aid of extenders or drains, the water collects in these areas contributing to water-related problems at the foundation. The basement apartment shows clear evidence of ongoing water problems at the foundation; lower portions of plaster walls exhibit blistering and the bases of door jambs have rotted. The exterior wood siding and trim suffers from deteriorating paint.

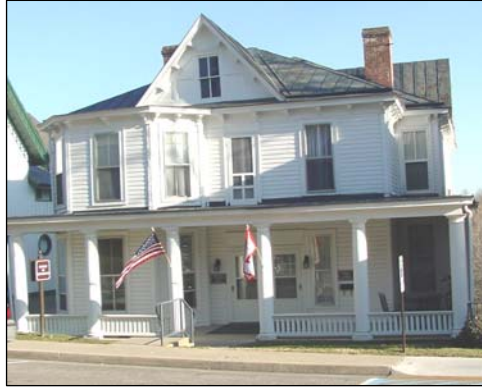
307 LETCHER AVENUE (CONSTRUCTION OFFICE)

The building at 307 Letcher Avenue is in good condition overall. The only identifiable problems include the metal roofing which is beginning to corrode and minor drainage issues where downspouts direct water against the foundation.

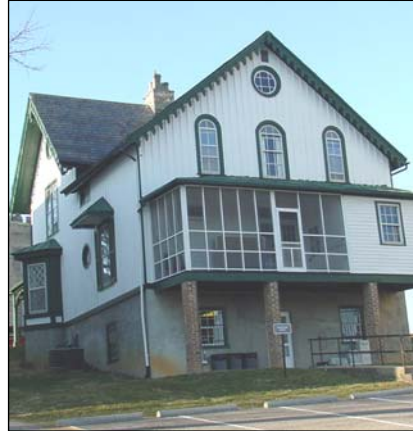
309 LETCHER AVENUE (PENDLETON-COLES HOUSE)

The main preservation concern at 309 Letcher Avenue is the condition of the slate roof. The patterned slate roof is beginning to show signs of failure and may need to be replaced in the near future. The house does not appear to be painted in original period colors. A paint analysis could uncover the original colors used on the exterior siding and wood trim.

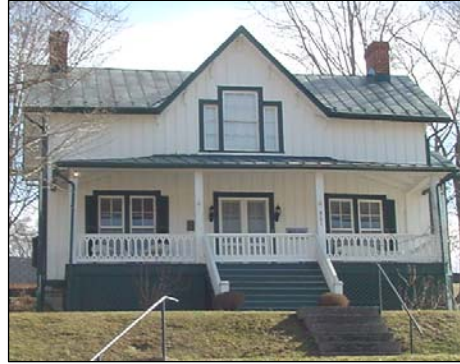
501 BROOKE LANE (BROOKE HOUSE)

The major preservation concern at 501 Brooke Lane is termite damage. The rear of the house sits close to the base of a hill. Roof drainage from the shed-roofed addition directs water towards the rear, where water is trapped against the base of the hill. The wood siding and wood floor framing are close to chronically wet at ground level, creating optimal conditions for termite infestation. It is important that regular termite inspections be carried out to control these infestations. Roof drainage should be directed away from the foundation with extenders or other drainage improvements. The residence is otherwise in good condition.

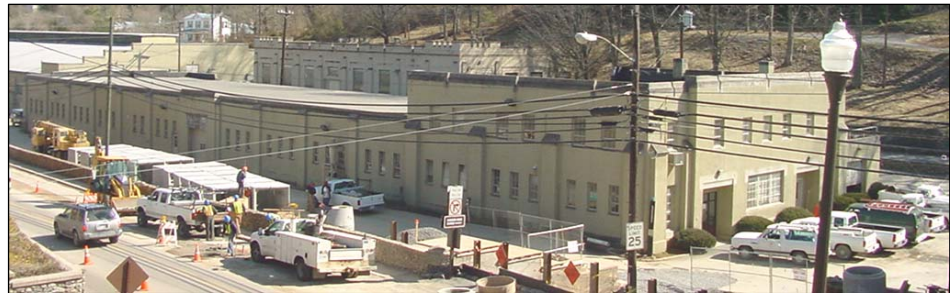
DEPARTMENT OF BUILDING AND GROUNDS

The Department of Building and Grounds building is surrounded by asphalt and concrete paving. The large roof surface is drained to a concrete-formed swale at the south foundation. The concrete swale was designed to collect water runoff and direct it towards the east, where water was drained to the asphalt paving. Currently, the concrete swale is cracked and full of vegetation and dirt. In addition, the swale was blocked with equipment at the east outlet during the time of the site survey. A new water drainage system must be designed to properly remove runoff from the south façade.
